**Flood Control Project Maintenance
Levee Inspections**

2013 Channel Summary Report

Madera County FCWCA

Flood Control Project Maintenance**Unit Cover Sheet****2013 Channel Inspection Results****Madera County FCWCA**

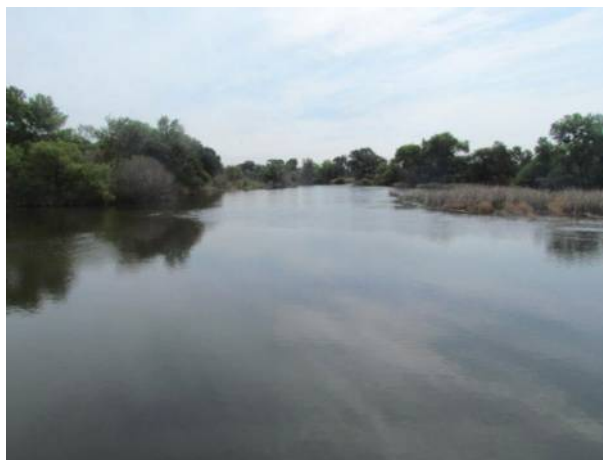
richard_c_20130827_063.JPG

Looking east (upstream) at channel from low water crossing.

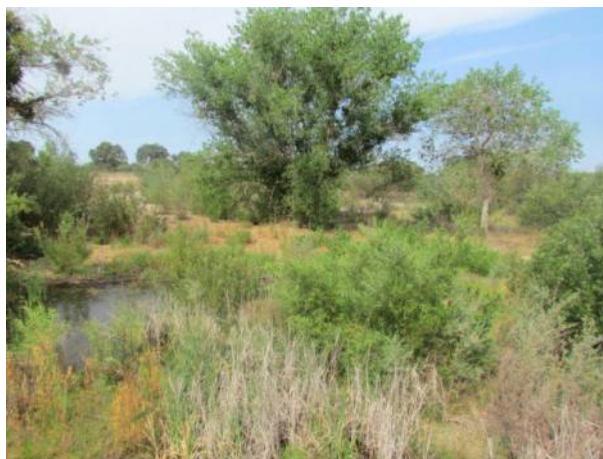
richard_c_20130827_064.JPG

Looking west (downstream) at channel from low water crossing.

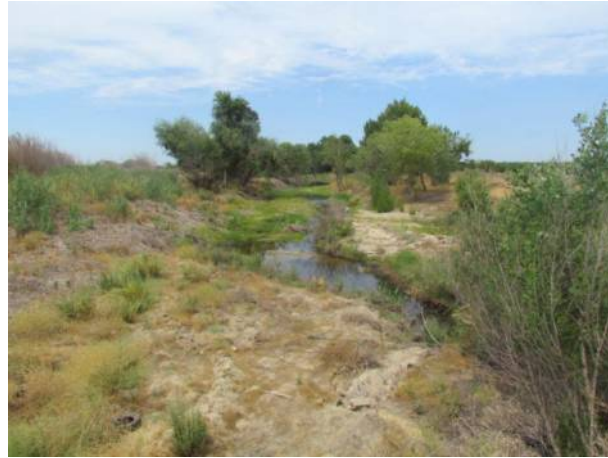
Levee Mile Report Line	36
Start Levee Mile	0.00
End Levee Mile	0.00
Location	
Category	Channels
Item	Shoaling / Sedimentation
Looking west (downstream) minimal shoaling in channel from Road 13.	
richard_c_20130827_073.JPG

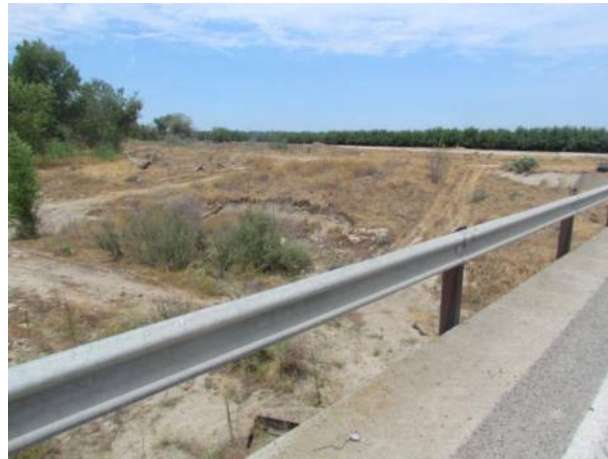
Levee Mile Report Line	37
Start Levee Mile	
End Levee Mile	
Location	
Category	Channels
Item	Erosion / Bank Caving
Looking southwest at small erosion in channel from Road 13.	
richard_c_20130827_074.JPG

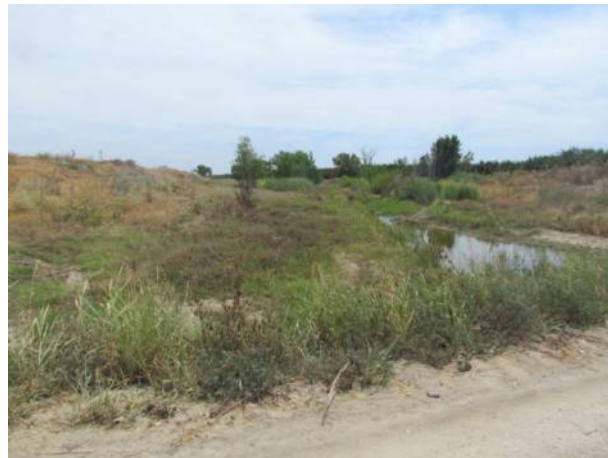
Levee Mile Report Line	40
Start Levee Mile	0.00
End Levee Mile	0.00
Location	
Category	Channels
Item	Vegetation & Obstructions
Looking east (upstream) at channel from Road 12.	
richard_c_20130827_075.JPG

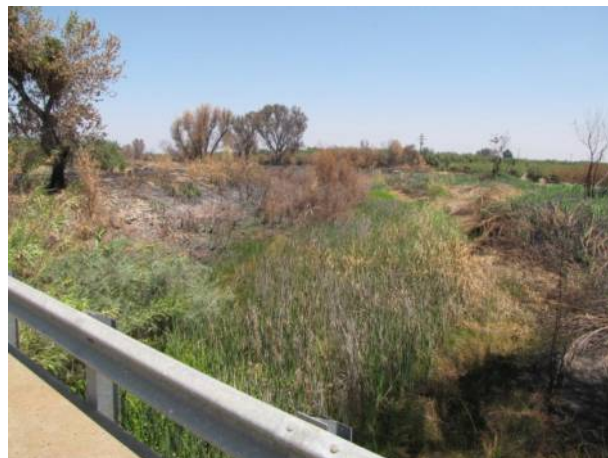
phillips_c_20130830_184.JPG

Berenda Slough at Rd 14 downstream Channel has been burned prior to the inspection. Photo taken 7-31-2013.

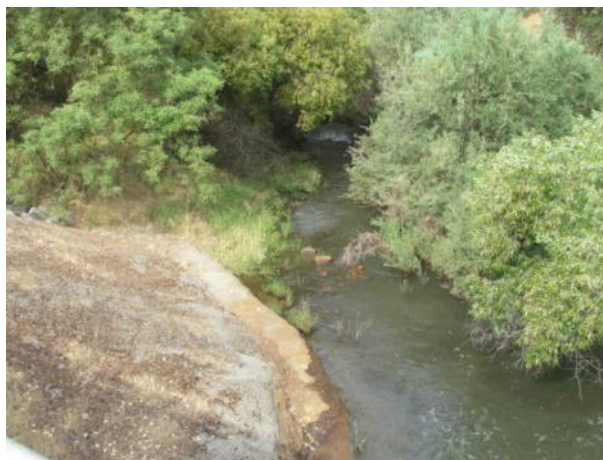
Levee Mile Report Line	6
Start Levee Mile	
End Levee Mile	
Location	
Category	Channels
Item	Vegetation & Obstructions
Looking downstream at willows in the middle of the channel from County Road 29.	
richard_c_20130827_043.JPG

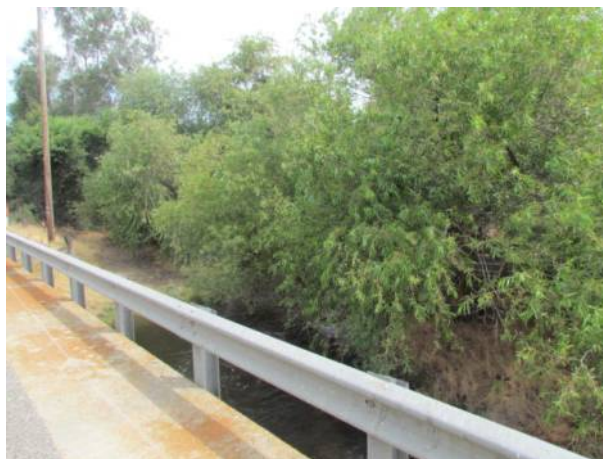
Levee Mile Report Line	11
Start Levee Mile	
End Levee Mile	
Location	
Category	Channels
Item	Vegetation & Obstructions
Looking upstream from Santa Fe Dr.	
richard_c_20130827_044.JPG

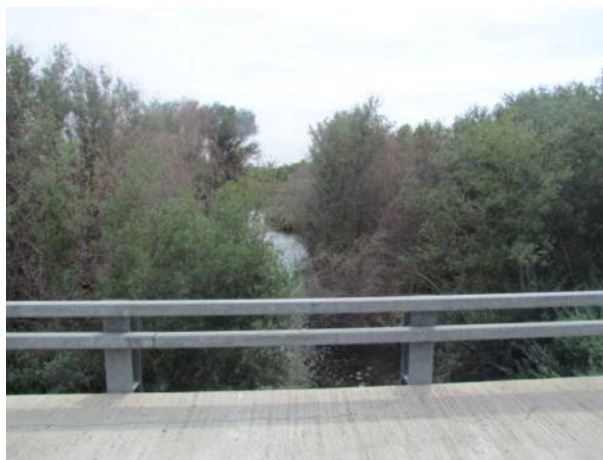
Levee Mile Report Line	21
Start Levee Mile	
End Levee Mile	
Location	
Category	Channels
Item	Vegetation & Obstructions
Looking east (upstream) at channel from White Rock Road.	
richard_c_20130827_046.JPG

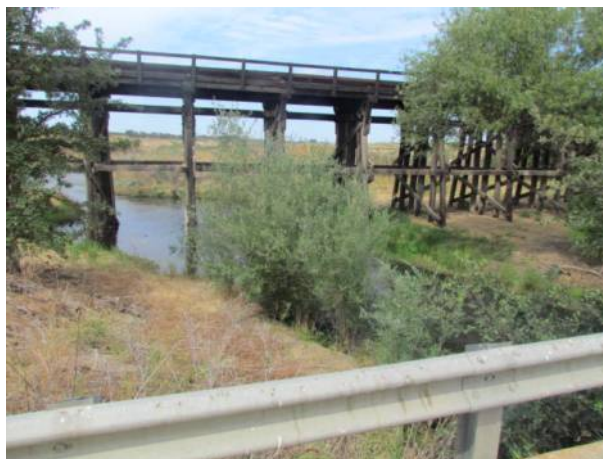
Levee Mile Report Line	26
Start Levee Mile	
End Levee Mile	
Location	
Category	Channels
Item	Vegetation & Obstructions
Looking west (downstream) at channel from White Rock Road.	
richard_c_20130827_047.JPG

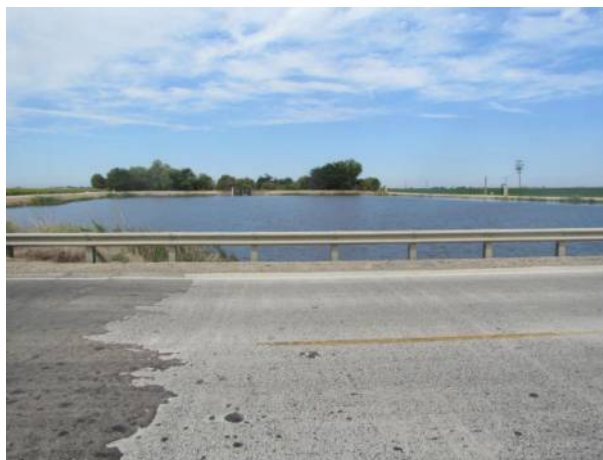
Levee Mile Report Line	46
Start Levee Mile	
End Levee Mile	
Location	
Category	Channels
Item	Vegetation & Obstructions
Looking west (downstream) at Check Dam from Road 15.	
richard_c_20130827_049.JPG

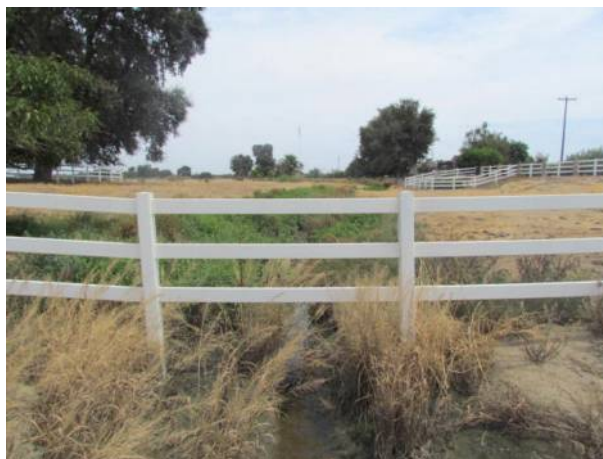
Levee Mile Report Line	51
Start Levee Mile	
End Levee Mile	
Location	
Category	Channels
Item	Vegetation & Obstructions
Looking east (upstream) at channel from Road 11.	
richard_c_20130827_053.JPG

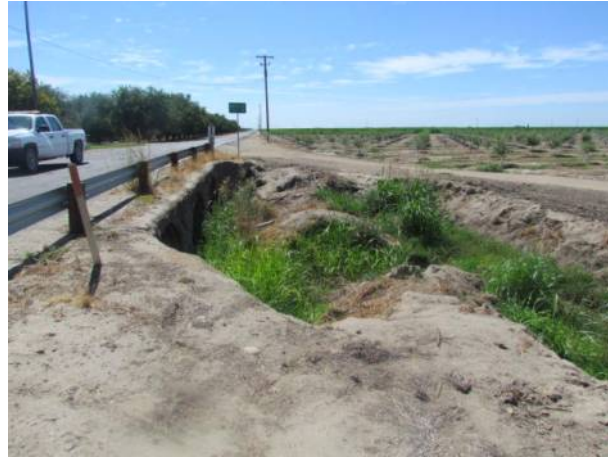
Levee Mile Report Line	72
Start Levee Mile	
End Levee Mile	
Location	
Category	Channels
Item	Shoaling / Sedimentation
Looking northwest at sedimentation in channel upstream of Washington Rd.	
richard_c_20130715_033.JPG

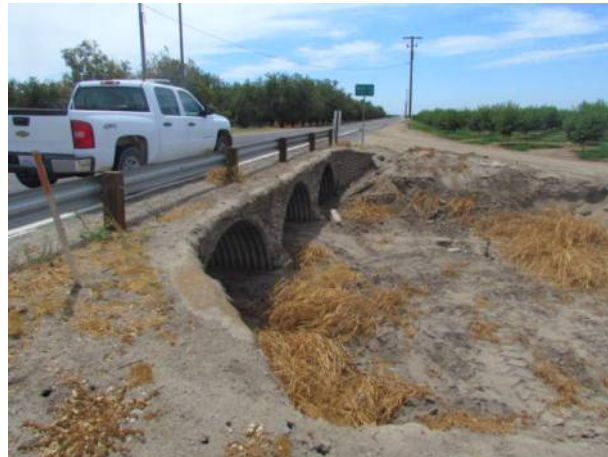
Levee Mile Report Line	72
Start Levee Mile	
End Levee Mile	
Location	
Category	Channels
Item	Shoaling / Sedimentation
Looking north at culverts crossing Avenue 25 & Washington Road.	
richard_c_20130827_058.JPG

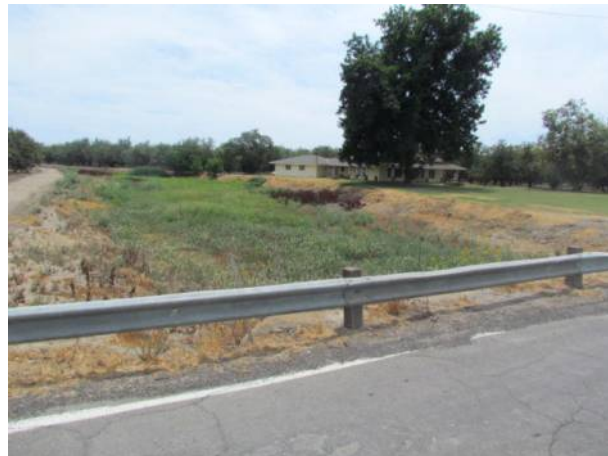
Levee Mile Report Line	76
Start Levee Mile	
End Levee Mile	
Location	
Category	Channels
Item	Vegetation & Obstructions
Looking west (downstream) at channel from Avenue 25 & Washington Road.	
richard_c_20130827_059.JPG

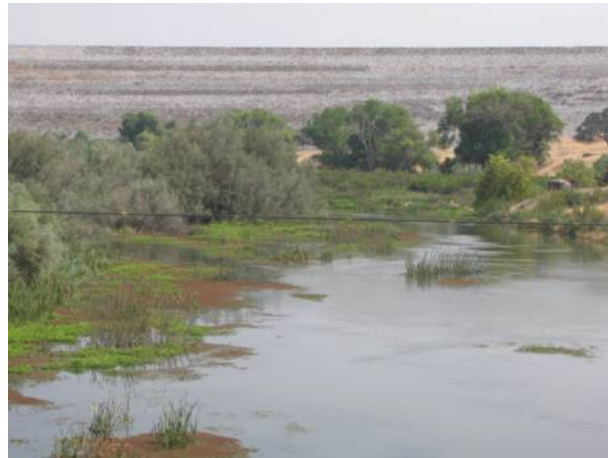
Levee Mile Report Line	1
Start Levee Mile	0.00
End Levee Mile	0.00
Location	
Category	Channels
Item	Vegetation & Obstructions
Looking back upstream at hidden Dam from Daulton Bridge crossing the Fresno River. Photo taken 7-30-2013.	
phillips_c_20130830_148.JPG

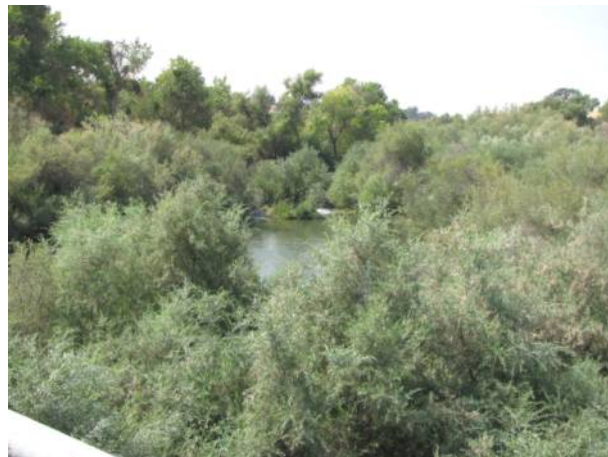
Levee Mile Report Line	6
Start Levee Mile	0.00
End Levee Mile	0.00
Location	
Category	Channels
Item	Vegetation & Obstructions
Fresno River downstream from bridge channel is becoming congested with wild growth. Photo taken 7-30-2013.	
phillips_c_20130830_149.JPG

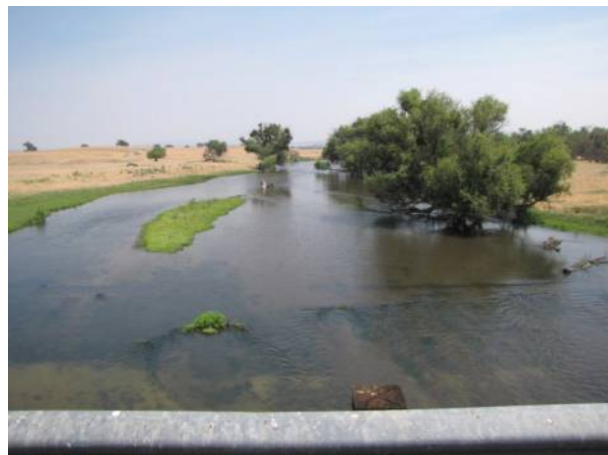
Levee Mile Report Line	11
Start Levee Mile	0.00
End Levee Mile	0.00
Location	
Category	Channels
Item	Vegetation & Obstructions
Standing on Timber Bridge crossing the Fresno River looking upstream. Photo taken 7-30-2013.	
phillips_c_20130830_150.JPG
